21.7.9 MANIOTOTO BRIDGES AND DISTRICT WIDE BRIDGE STRATEGY UPDATE

Doc ID: 551311

To provide an update for the three Maniototo Bridges currently closed to traffic, along with an update on the development of a district wide bridge strategy.

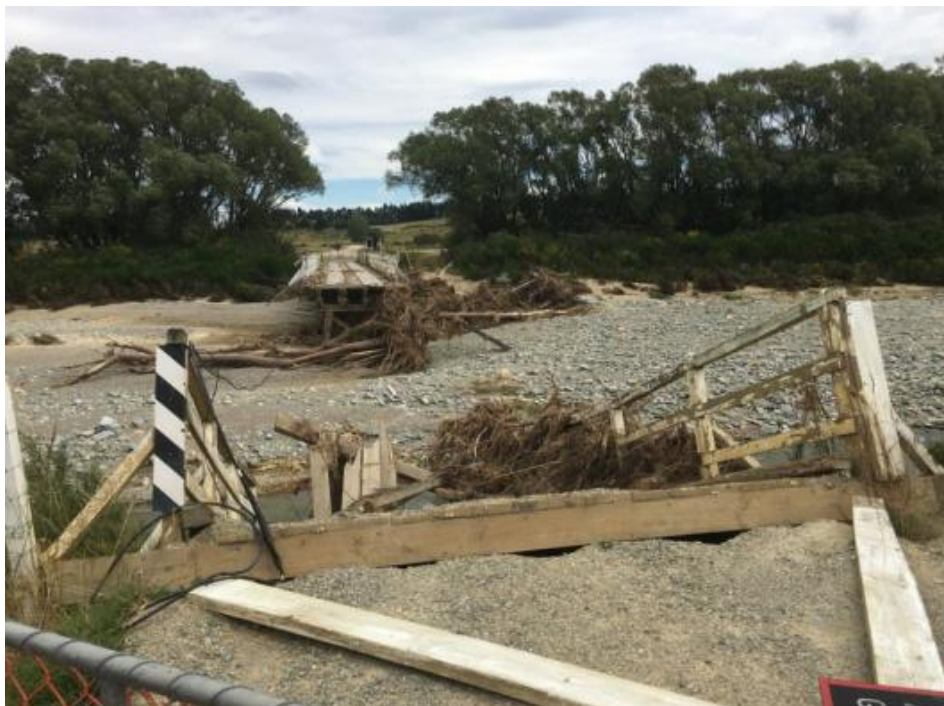
The 13-span timber bridge at Scott Lane was significantly damaged in the weather event, with four of its 13 spans being physically swept away.

The Scott Lane timber bridge is 91 years old and was at the end of its economic life. It was heavily restricted to heavy vehicles prior to this weather event and subsequent closure and repair of the existing bridge is not a viable option.

Scott Lane bridge damage

Beca are investigating more cost-effective options that may service this area. While the bridge has been closed, road users have been utilising an existing ford crossing point. Council's contractor has been undertaking basic maintenance on the ford crossing point and this has provided access under the normal low flow conditions of the Kyeburn.

A more permanent option is being investigated for this location, and it is possible that a concrete wash over box culvert may be able to service Scott Lane users - with the exception of high flooding situations when an alternative route is available.

A concrete wash over box culvert would be a much more cost-effective and resilient solution compared to a new replacement bridge. Although the investigation phase is well underway, it is too early to estimate costs involved.

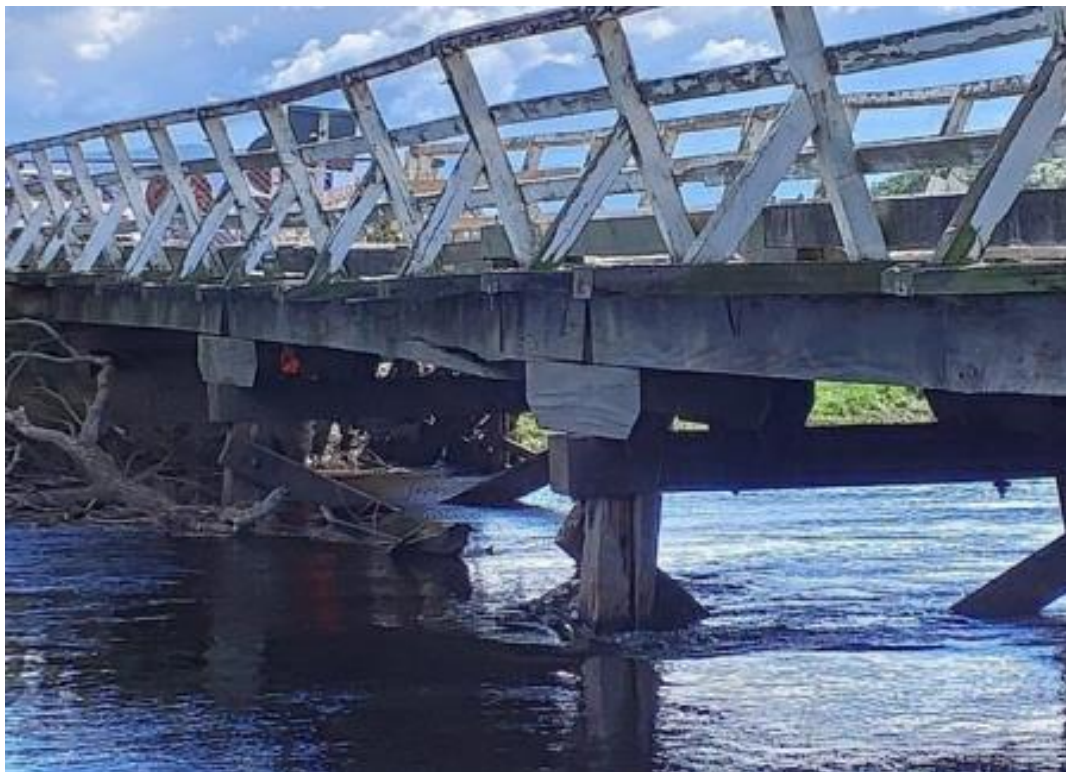
This bridge was closed to traffic because at least one of the primary load bearing timber beams is showing significant longitudinal cracking. It was also noted that other timber components were in poor condition due to their age (warped primary load carrying beams, deep cracking, bowed beams etc.).

At 91 years of age, the Maniototo Road bridge was nearing the end of its useful life and was already heavily restricted to large vehicles prior to this flood event. There was already existing deterioration occurring in most of its structural timber components.

Maniototo Road bridge damage

This bridge will have a principal inspection undertaken by Beca in September, from which will determine what loading this bridge is capable of in its current condition or if moderate repairs (if possible) were made.

There is a possibility this bridge could be opened to light vehicles (<3500kg) with moderate repairs, but this cannot be confirmed until the principal inspection and site testing have been undertaken. The overall deterioration of this structure (due to its age) may also make reopening challenging if further significant issues are found during the inspection.

This location is also known as *Halls Ford*, and there are suggestions this was historically a ford crossing point on the Taieri River. Assessment on site has determined a 'deep ford crossing' (600mm depth approx.) may be possible to construct on site.

Construction of a deep ford crossing would involve excavating suitable approaches on each side of the riverbank and placing rock stabilised platform across the bed of the river, to an estimated overall cost of \$15,000. This would only be suitable for the likes of farm equipment that is capable of crossing such a depth.

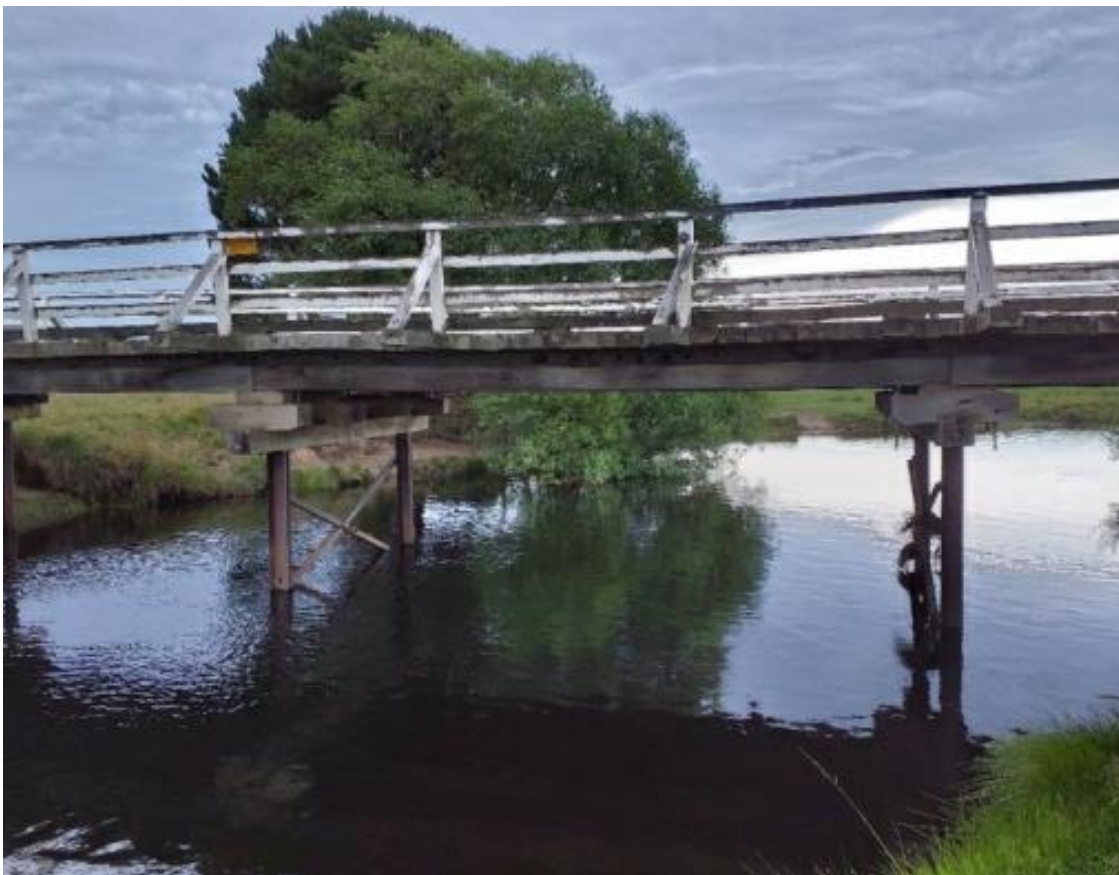
This bridge was closed because it has unsupported beams at two locations resulting in an unsafe load path through the deck members. There was also severe decay present at various beam ends and visible sag on one span.

There is no definite age for this bridge recorded, but old plans suggest it is at least 70 years of age and is primarily constructed from timber with steel tramway rail piles.

Linnburn Runs Road bridge damage

This bridge will have a principal inspection undertaken by Beca in September, from which will determine what loading this bridge is capable of in its current condition or if moderate repairs (if possible) were made.

It is anticipated that this bridge may be possible to open to light vehicles (<3500kg) with moderate repairs, but this cannot be confirmed until the principal inspection and site testing have been undertaken. The overall deterioration of this structure (due to its age) may also make reopening challenging if unexpected results are found during the inspection.

This site was not deemed appropriate for a ford crossing due to the depth of the river. Cost-effective bridge alternatives are not considered favourable for this site, however Council will discuss this in more detail with the Structural Engineer when on site for the principal inspection.
